ENSKTA  
MECHANICAL  
LAYOUT

EXAKTA VXL13 10.22.99

EXAKTA VX116  
DISASSY STEP (2)

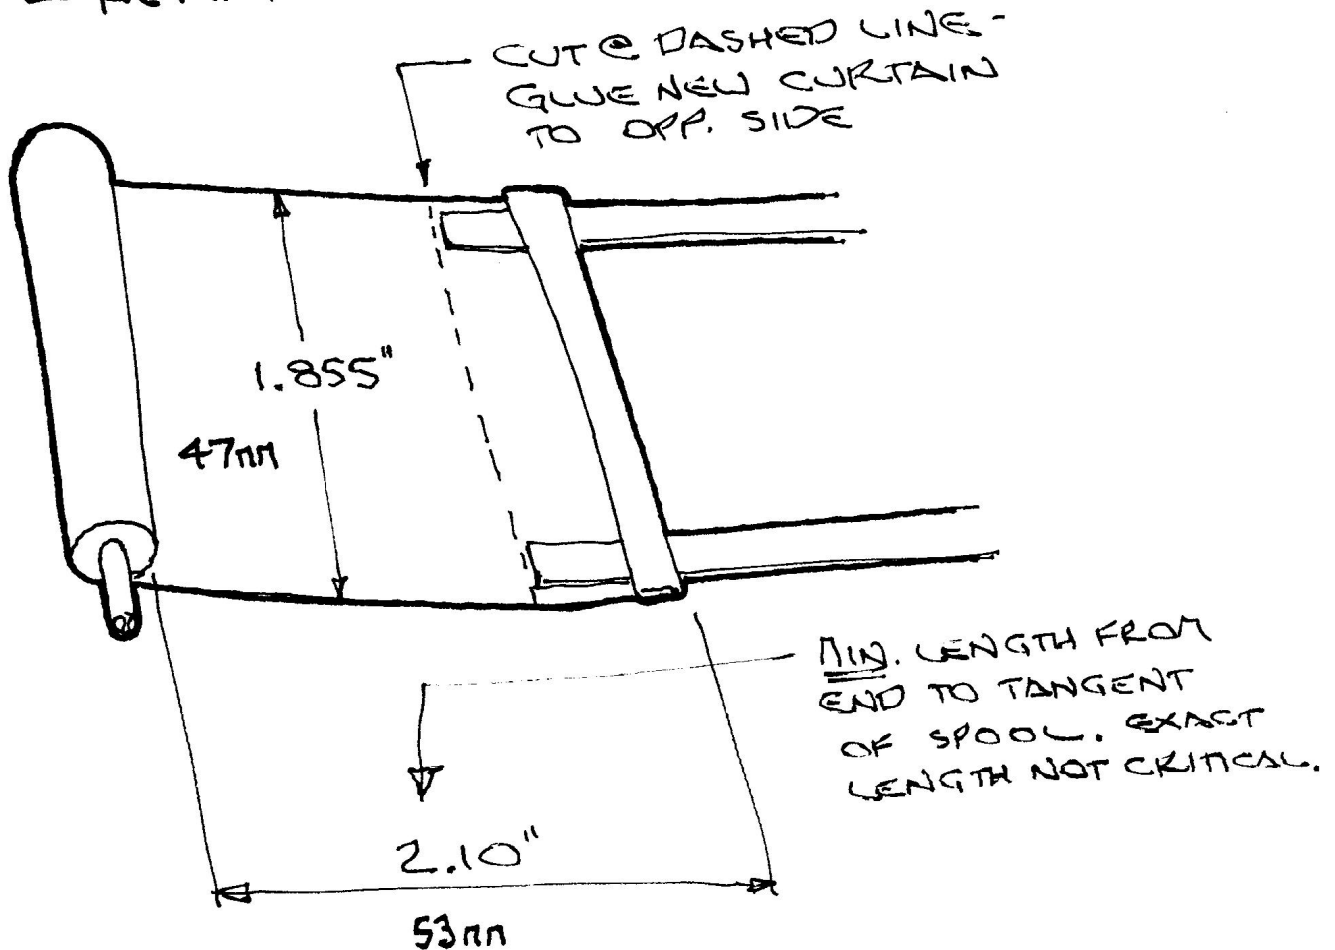
EXAKTA  
#1 CURTAIN

EXAKTA END CLIPS ARE NOT REMOVABLE.  
CURTAIN MUST BE CUT, LEAVING A  
SHORT STUB TO GLUE ON TO THE  
NEW CURTAIN - SIMILAR TO CONTAXS.

- RELEASE TENSION ON BOTH CURTAINS
- REPLACE #1 CURTAIN FIRST:
  - 1 - REMOVE #2
  - 2 - REMOVE & REPLACE #1
  - 3 - REINSTALL #2
- RETENSION: COCKED - #1 = 7.5, #2 = 5.5 TURNS

CURTAIN CUT DIMENSIONS:  
47mm x 70mm

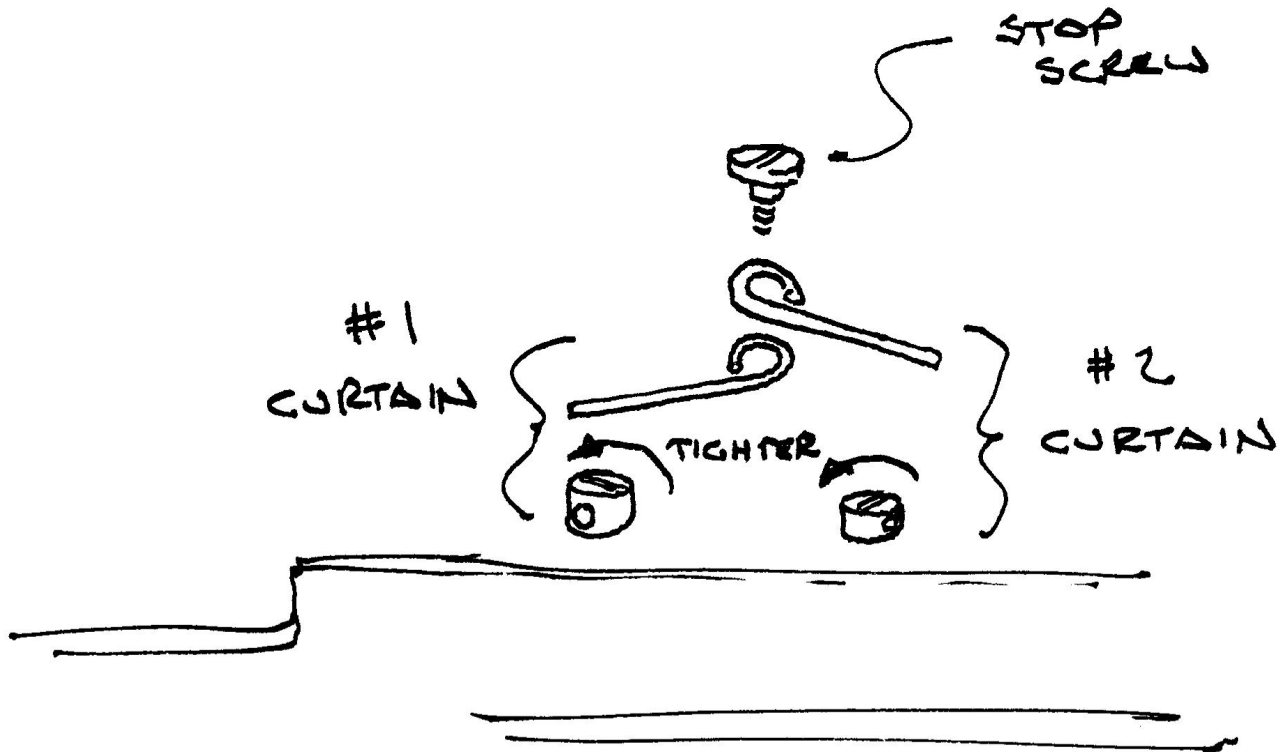
# EXAKTA SHUTTER SPRING ADJUSTMENT

Located under top right cover, next to slow speed dial

- ① REMOVE STOP SCREW (STOP WIRES WON'T LET SPINDLES TURN)
- ② HOLD SPINDLE w/ SCREWDRIIVER (LEFT HAND) WHILE WITHDRAWING STOP WIRE WITH TWEEZERS (RIGHT HAND)
- ③ TURN SPINDLE IN  $\frac{1}{2}$  TURN INCREMENTS, REINSERT STOP WIRE, REPLACE STOP SCREW
- ④ TEST, REPEAT AS REQ'D.

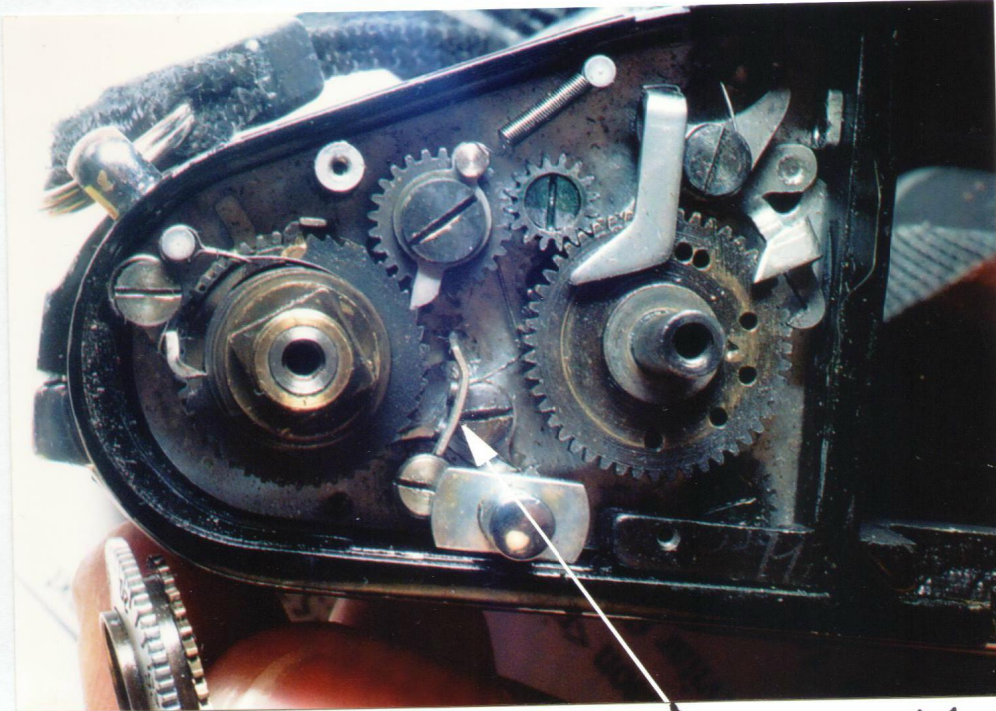
This camera has a broken frame counter - possibly from a careless reassembly.

↑ RATCHET TEETH

← RATCHET W/BROKEN PAWL (NOTE 2 RIVET HEADS; THIN SPRING STEEL STRIP UNDER RIVETS SHOULD EXTEND FORWARD & ENGAGE RATCHET TEETH (REMOVED & LEFT))

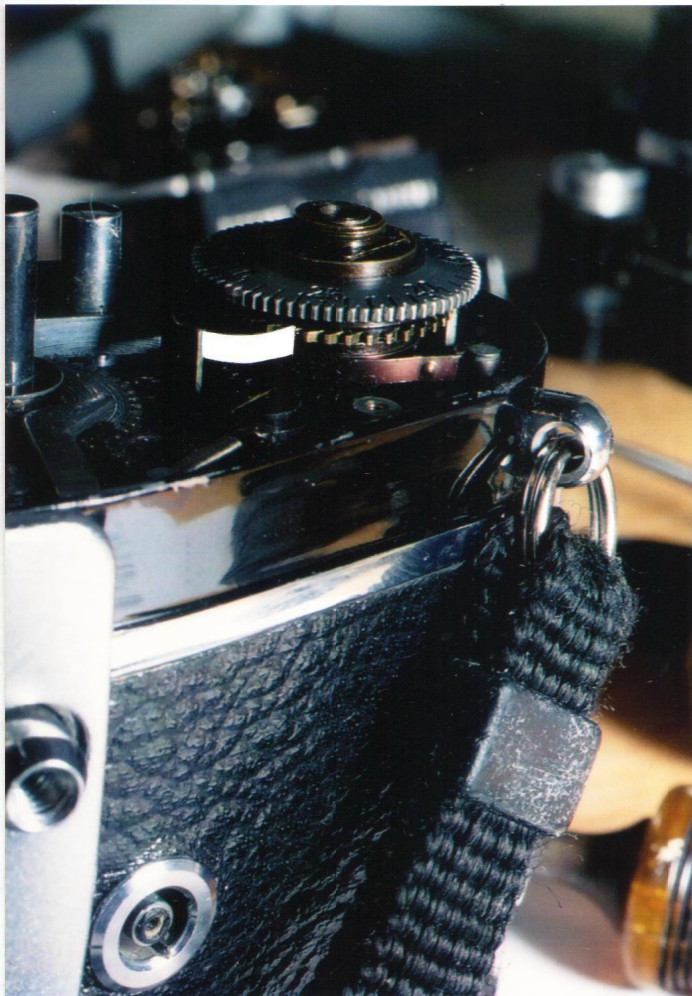
← WHITE AREA IS WHERE PAWL SHOULD BE.
