ENSKTA  
MECHANICAL  
LAYOUT

EXAKTA VXL13 10.22.99

EXAKTA VX116  
DISASSY STEP (2)

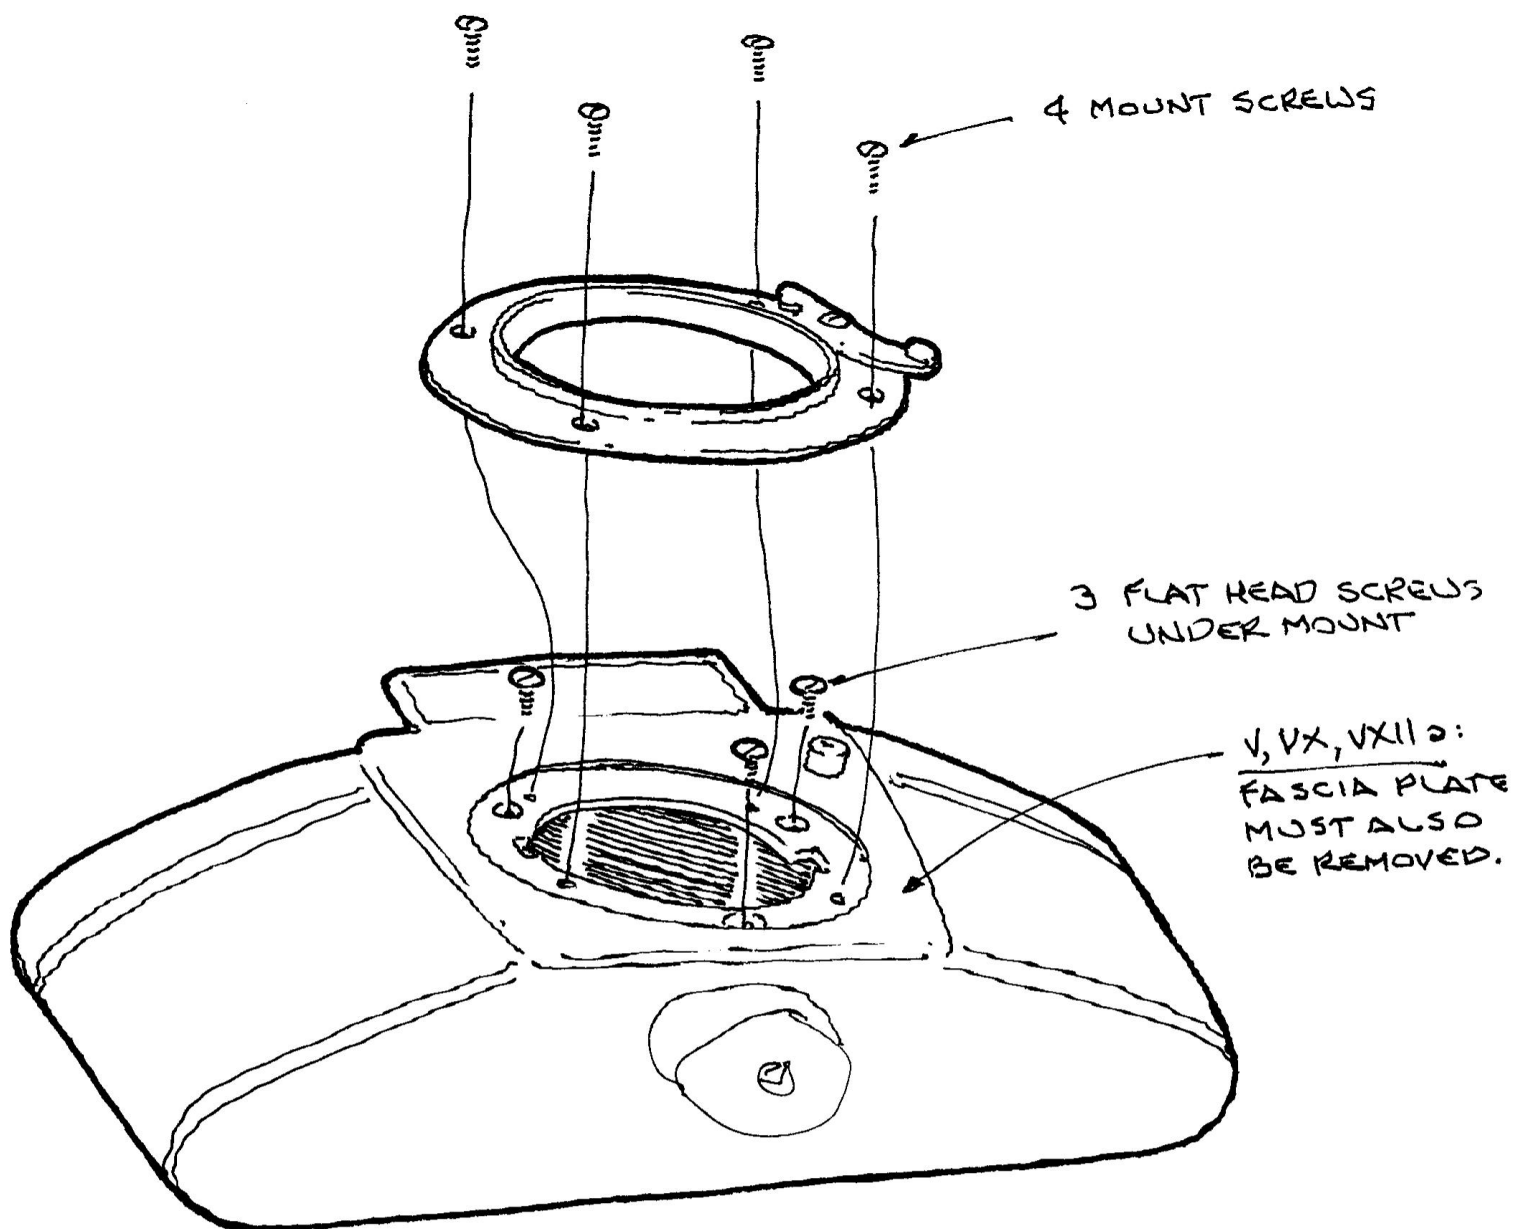
**V, VX, VX112** FRONT FASCIA  
PLATE MUST COME OFF TO  
CLEAR VF RELEASE LINKAGE.

REQUIRES 2  
SCREWDRIVERS

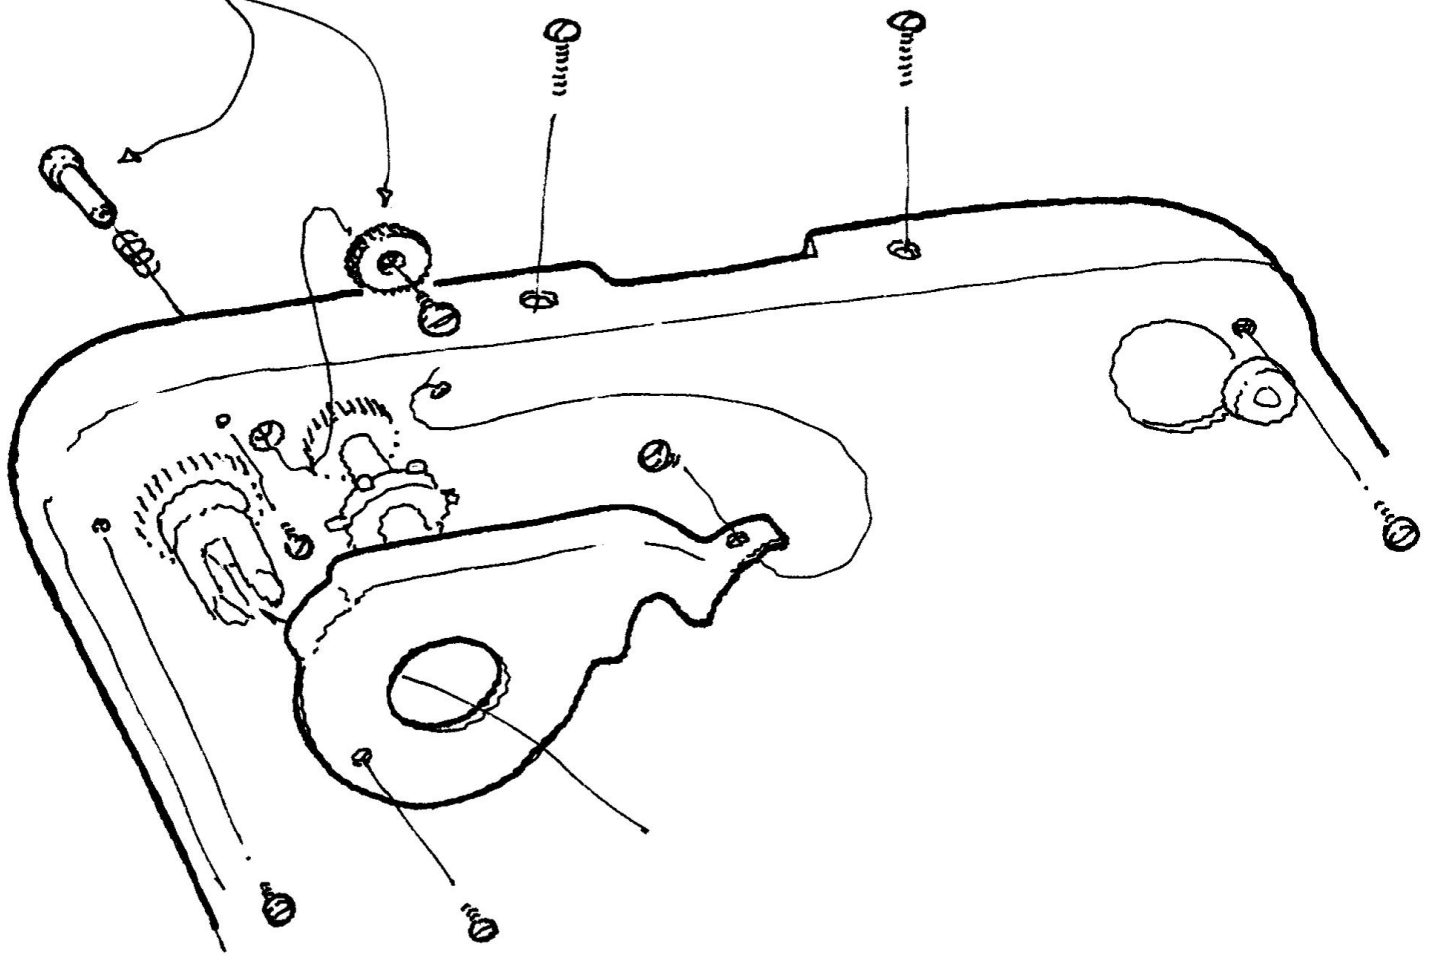
EXAKTA VX116  
DISASSY STEP (3)

( SHUTTER MODULE CAN  
NOW BE LIFTED OUT OF CHASSIS )

REASSY: FITS ARE CLOSE - COCK SHUTTER  
FIRST TO TIGHTEN CURTAINS SO THEY  
WON'T SNAG ON BODY CASTING.
